SOILS, GEOLOGY AND LAND CONTAMINATION

INTRODUCTION

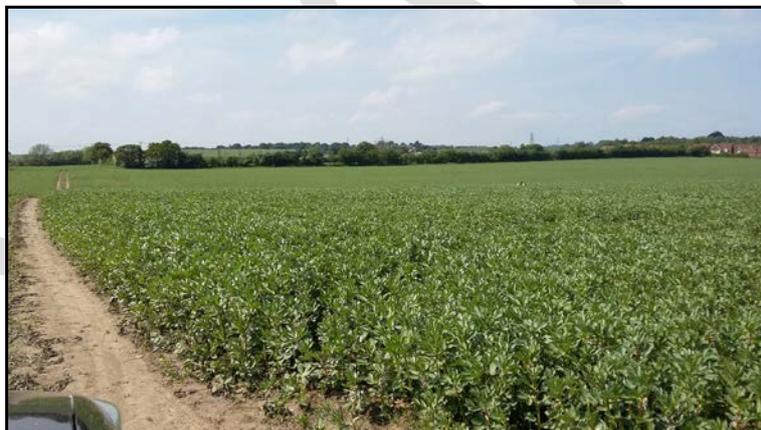
1.21 The site currently comprises agricultural fields of bean and wheat crops. Two public footpaths pass through the site traversing east to west and north to south. There are currently no buildings or structures located on site.

Photograph 11.1: View West from the Eastern Area of Site

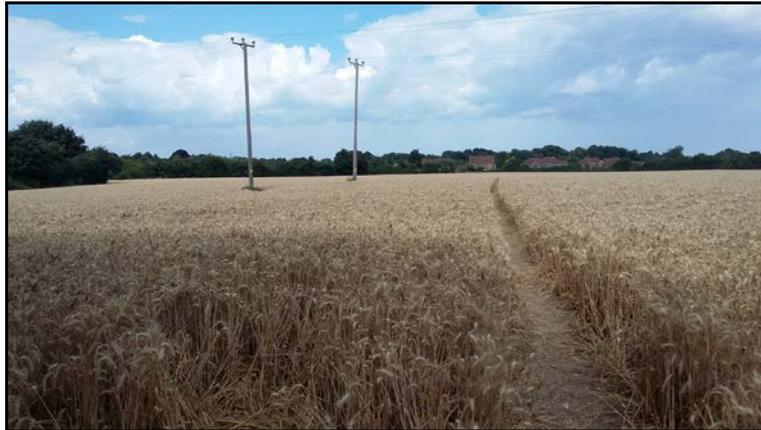
Photograph 11.2 View Northeast across the Western Area of Site

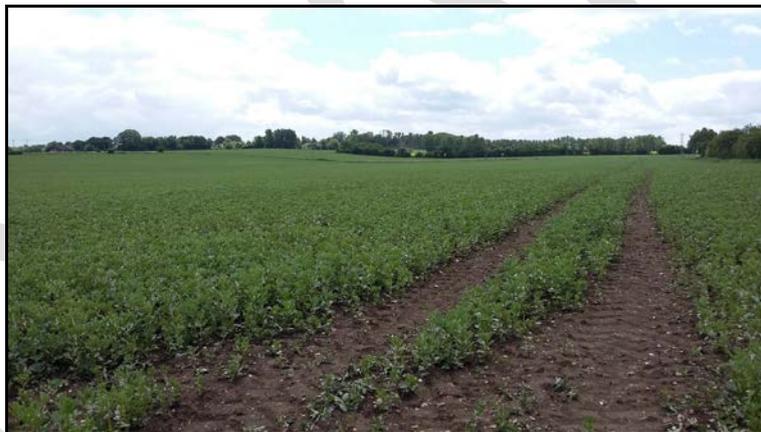
Photograph 11.3: View of the Shallow Valley Area in the North East of Site

1.22 The site gradient gradually slopes to the south, with the majority of the site recorded at approximately 34 - 35m above ordnance datum (AOD). Two very shallow valley areas are located to the northwest and north east of site, dipping to approximately 29m AOD at the shallowest area.

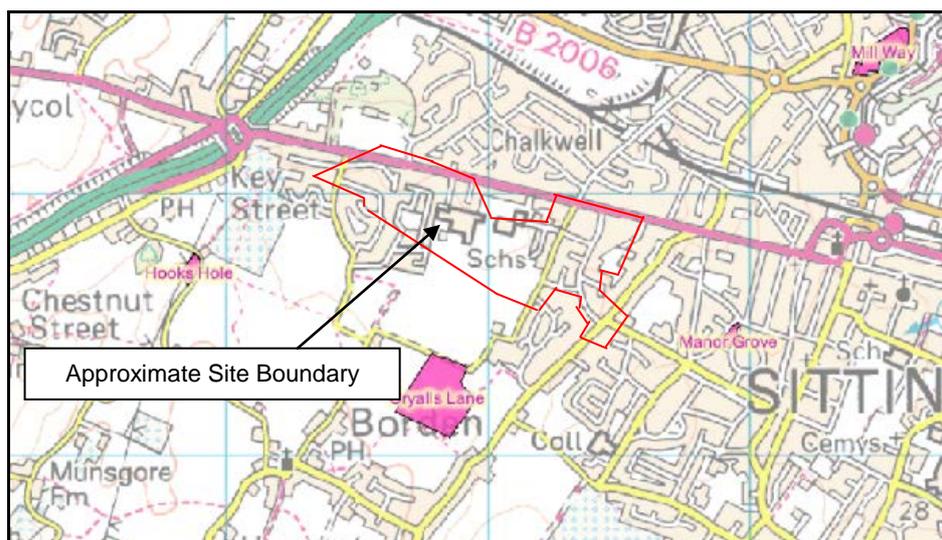
Figure 11.1: Landfills in the Vicinity of Site (Source: Environment Agency)

- **Historical Landfills** – There are four (4No.) records of historic Environment Agency landfill sites within 1,500m of the study site, as detailed below:
 - One (1No.) historic landfill located directly adjacent to the south south-eastern boundary of the site, known as Cryalls Lane. The landfill was operated by Swale Rural District Council accepting inert, commercial, household and liquid sludge between c. 1956 and 1985.
 - One (1No.) historical landfill known as 'Hooks Hole' is located directly adjacent to the south western boundary of the site, accepting inert waste (no dates available).
 - Two (2No.) historic landfill sites located 716m east (Manor Grove - inert) and 1,405m north east (Mill Way - not specified) of site.
 - One (1No.) record is also detailed for a historical Local Authority refuse tip, located 9m southwest of site, potentially operational in 1969.

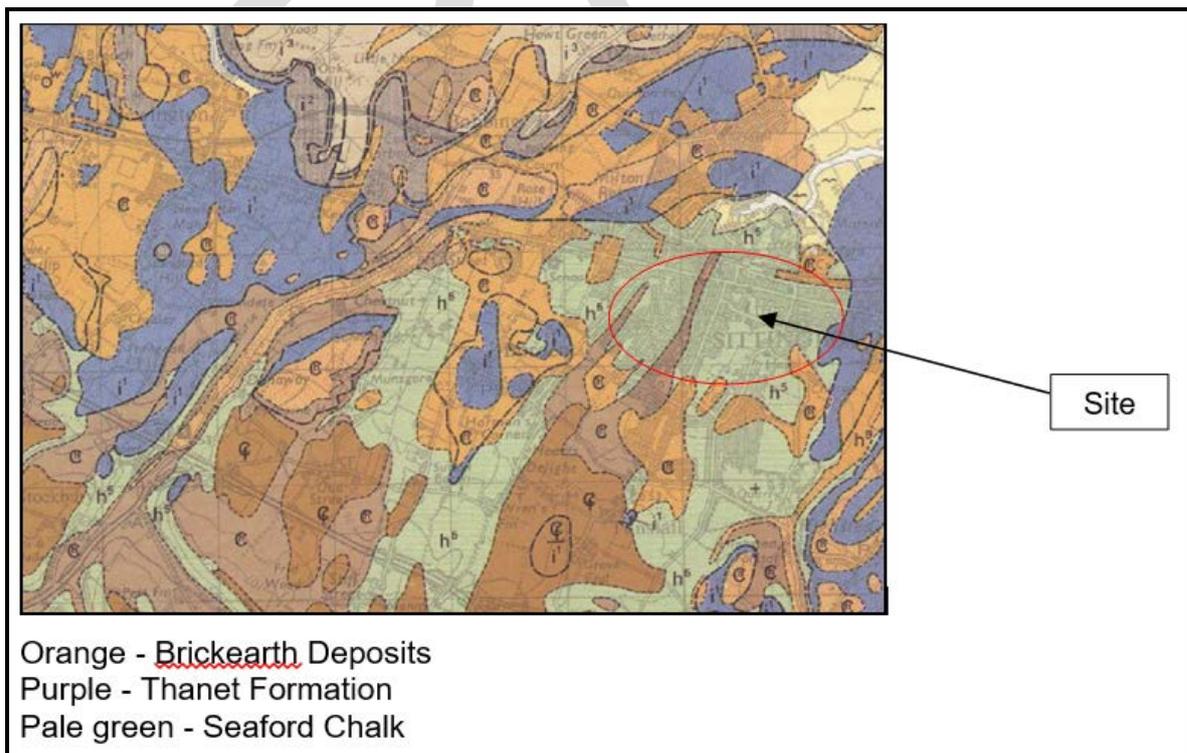
Figure 11.2: Geological Map Summary

1.28 A review of readily available information including the BGS website and the published BGS Sheet 272 (Chatham) Solid and Drift edition indicates the site is partially located over superficial deposits comprising Brickearth / Head Deposits consisting gravel, sand, silt and clay deposits. The bedrock geology underlying site comprises the Thanet Sand Formation

over the central southern area of site, the north western corner and far south eastern corner with Seaford Chalk outcropping the remaining area.

1.32 The bedrock geology underlying the central southern area of site, the north western corner and far south eastern corner of site form part of the Paleogene sedimentation and include shallow marine, coastal and fluvial sediment classified in the site area as Thanet Sand Formation. This consists of silty, fine-grained sand which tends to be clayey and siltier in the lower part. The colour varies between greenish and brownish grey, but at the surface the sands is more pale yellowish grey.

1.33 The main bedrock geology underlying site comprises cretaceous deposits forming part of the succession of the White Chalk. The site is located on the upper part of the Chalk Group, distinguished as Seaford Chalk. This formation is characterised by soft, white, non-nodular Chalk with regular bands of large flints.
